AES PUERTO RICO, L.P.
Guayama, Puerto Rico

**August 12, 2016 NPDES Enforcement
Case Support Inspection Briefing**

José A. Rivera, BSCE
Senior Environmental Engineer
Caribbean Environmental Protection Division

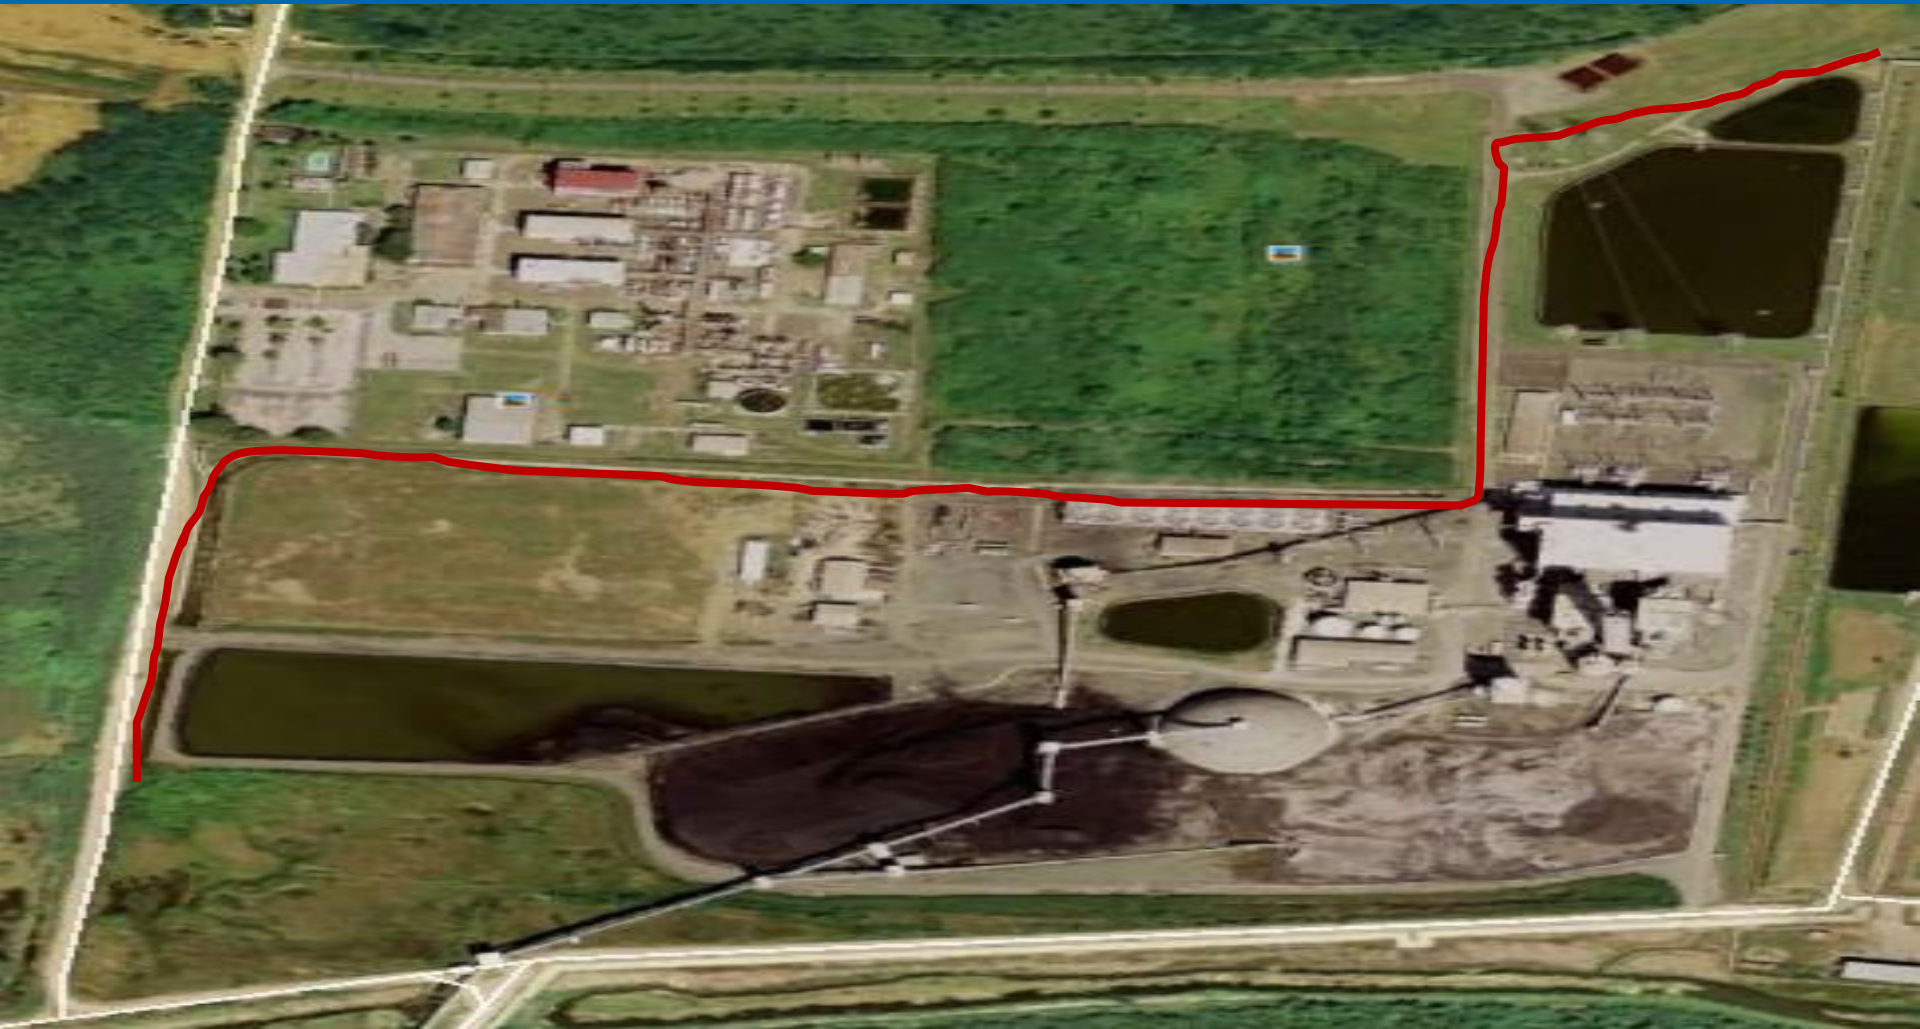
- Run-on from offsite and AES (non-regulated) site collected in concrete channel that discharges into wetlands

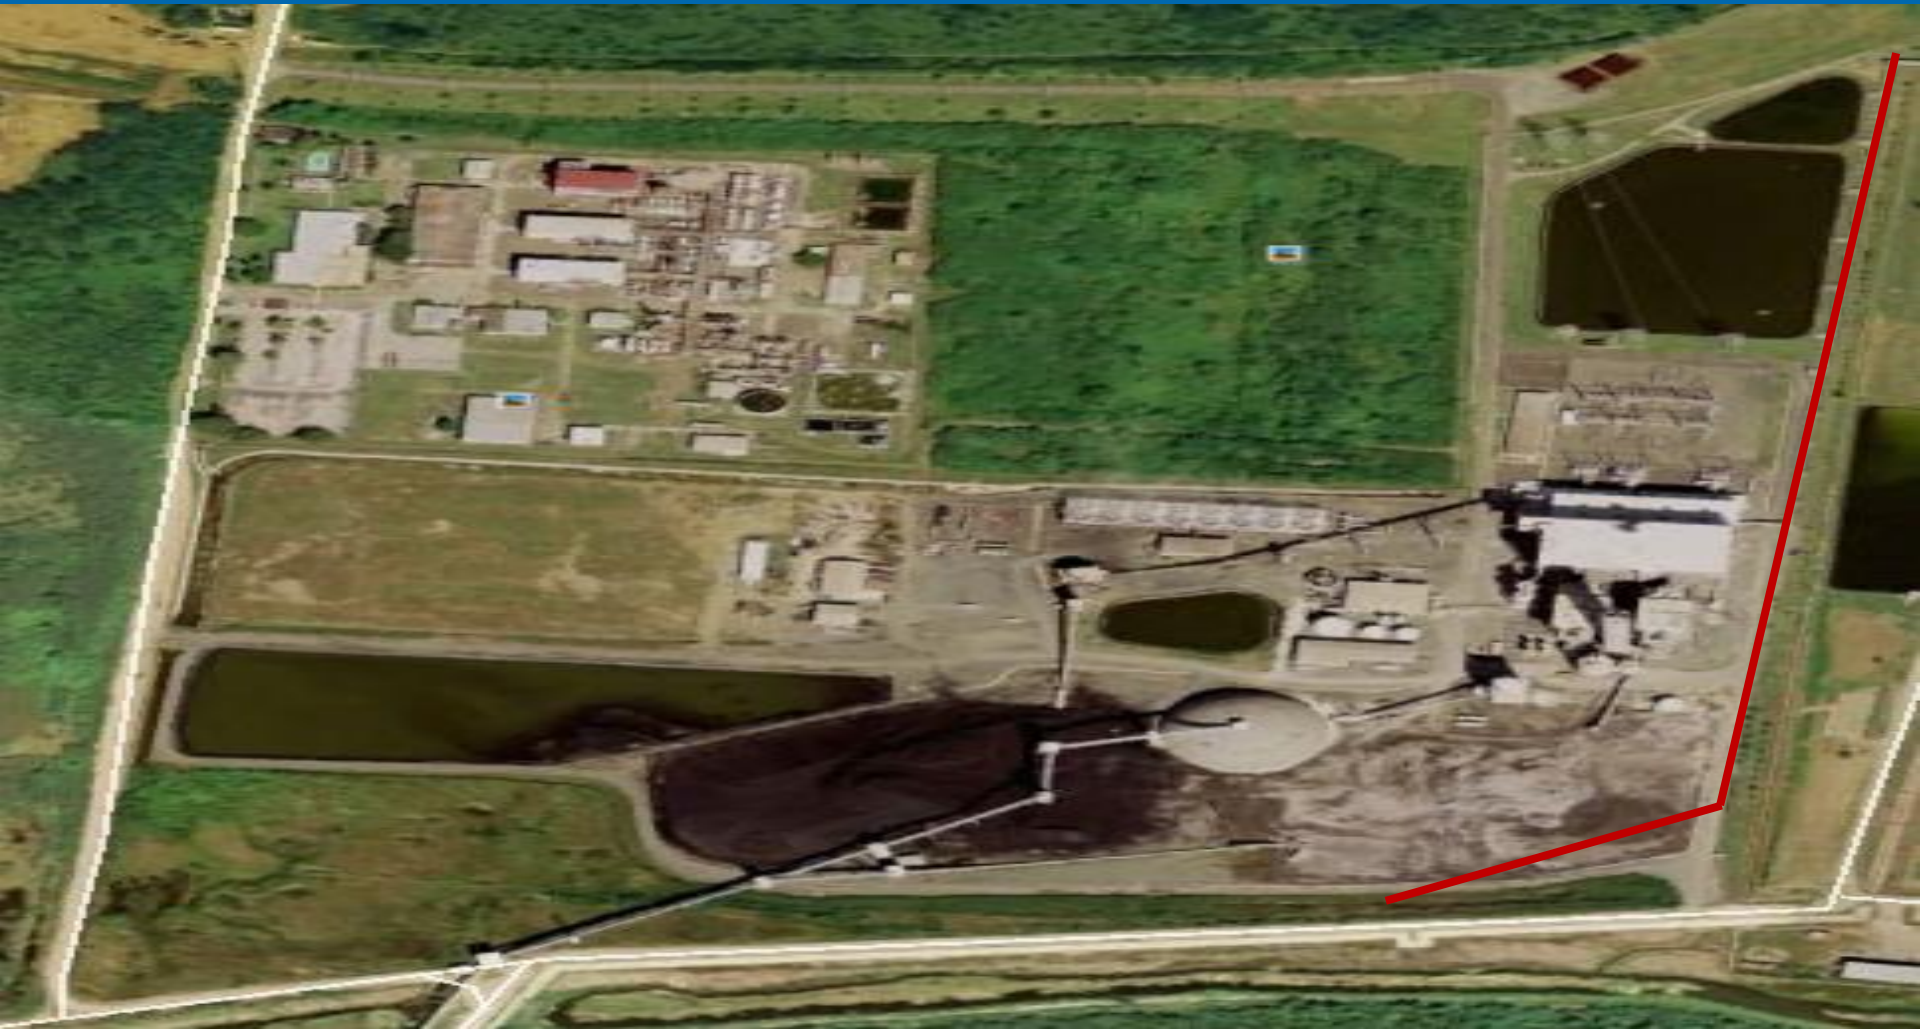
- Run-on from neighboring lands on north side is collected in underground pipeline that discharges into wetlands

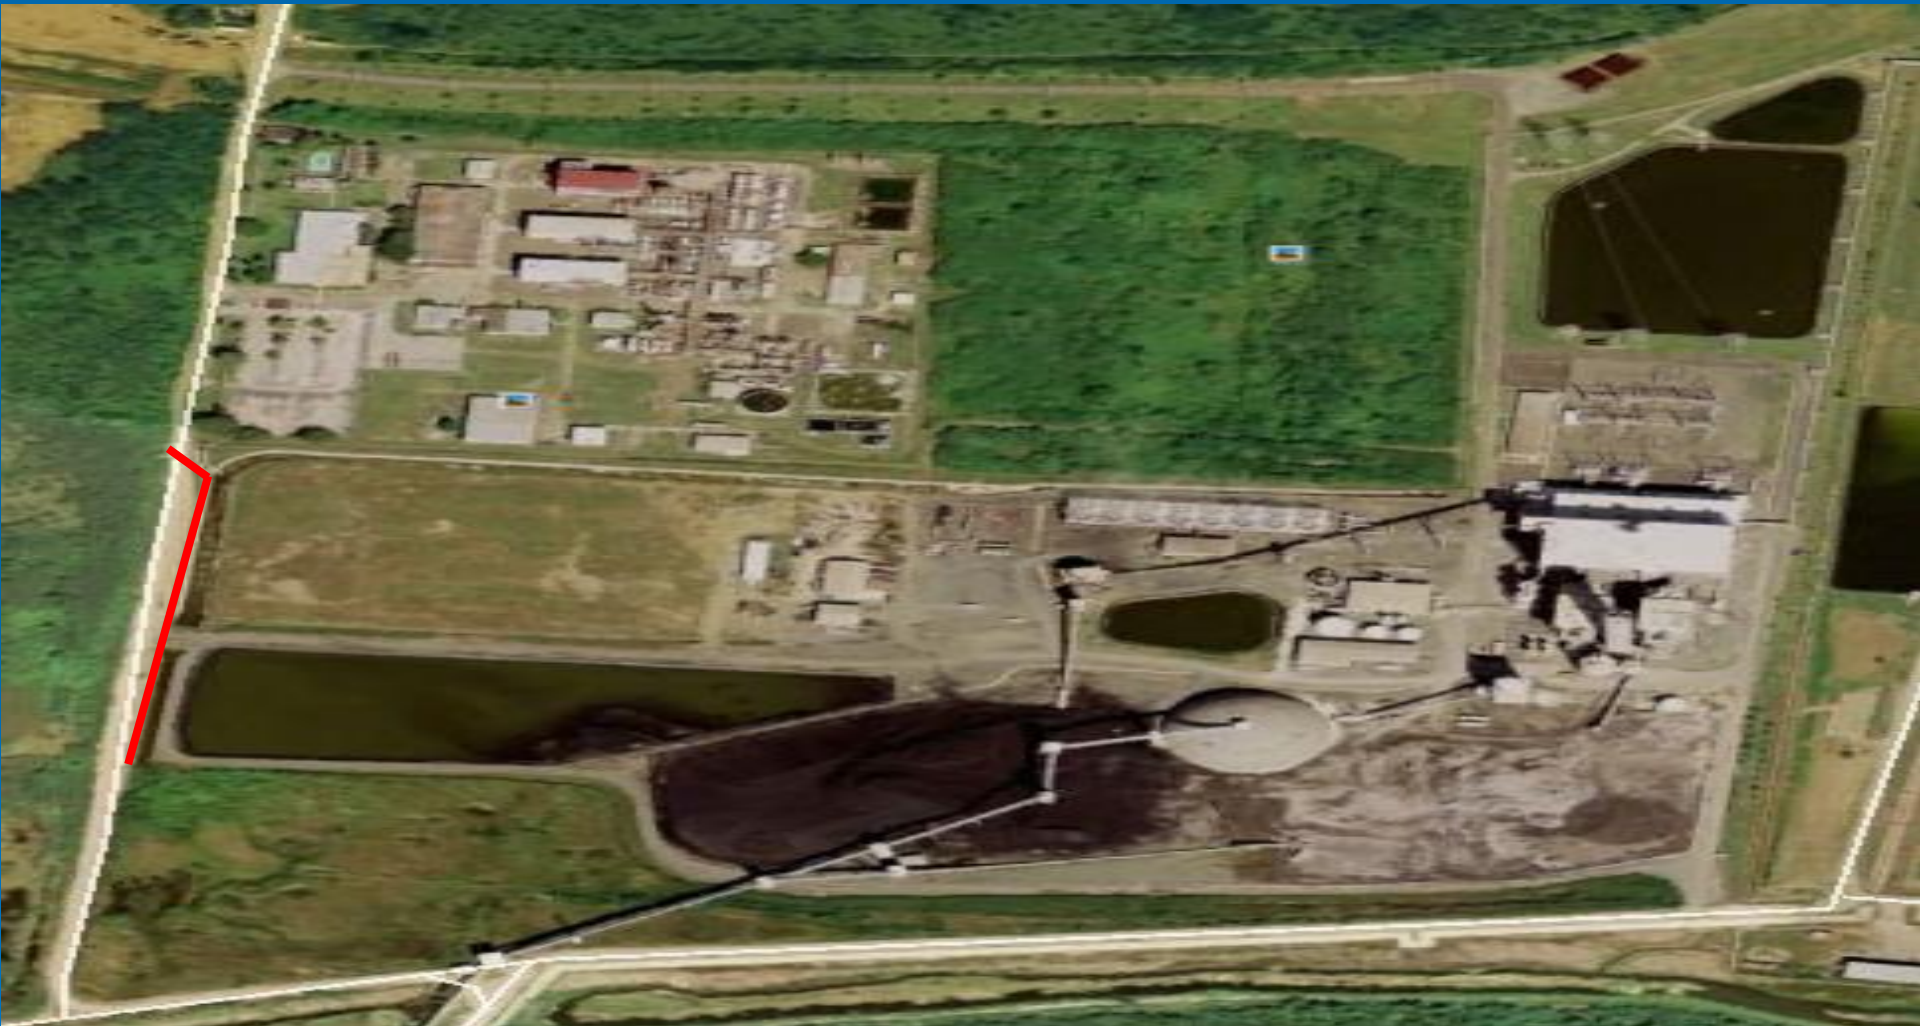
- Run-off from TAPI's facility is collected and discharged into wetlands side-by-side AES's Outfall 003.

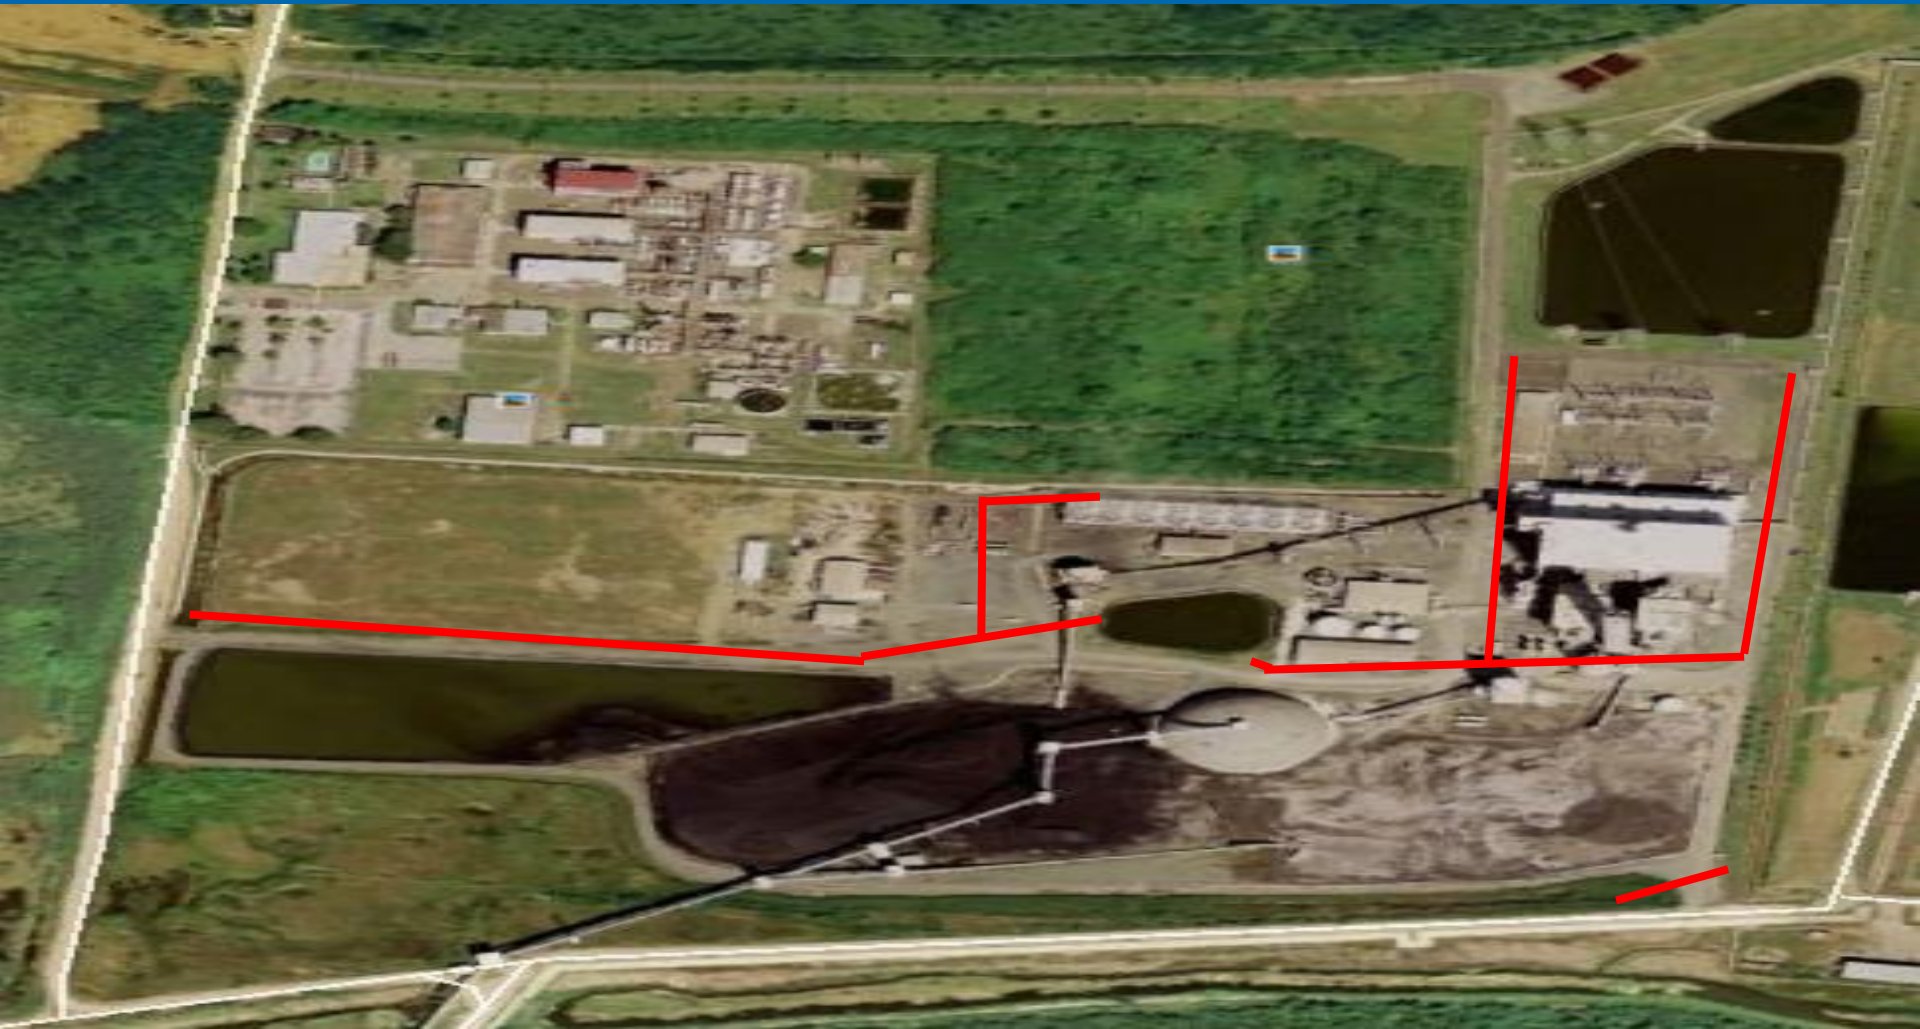
- AES' site stormwater runoff associated with industrial activity is collected in a stormwater collection and discharge system. AES reuses the runoff collected at SW Pond for water production prior to overflow discharge.

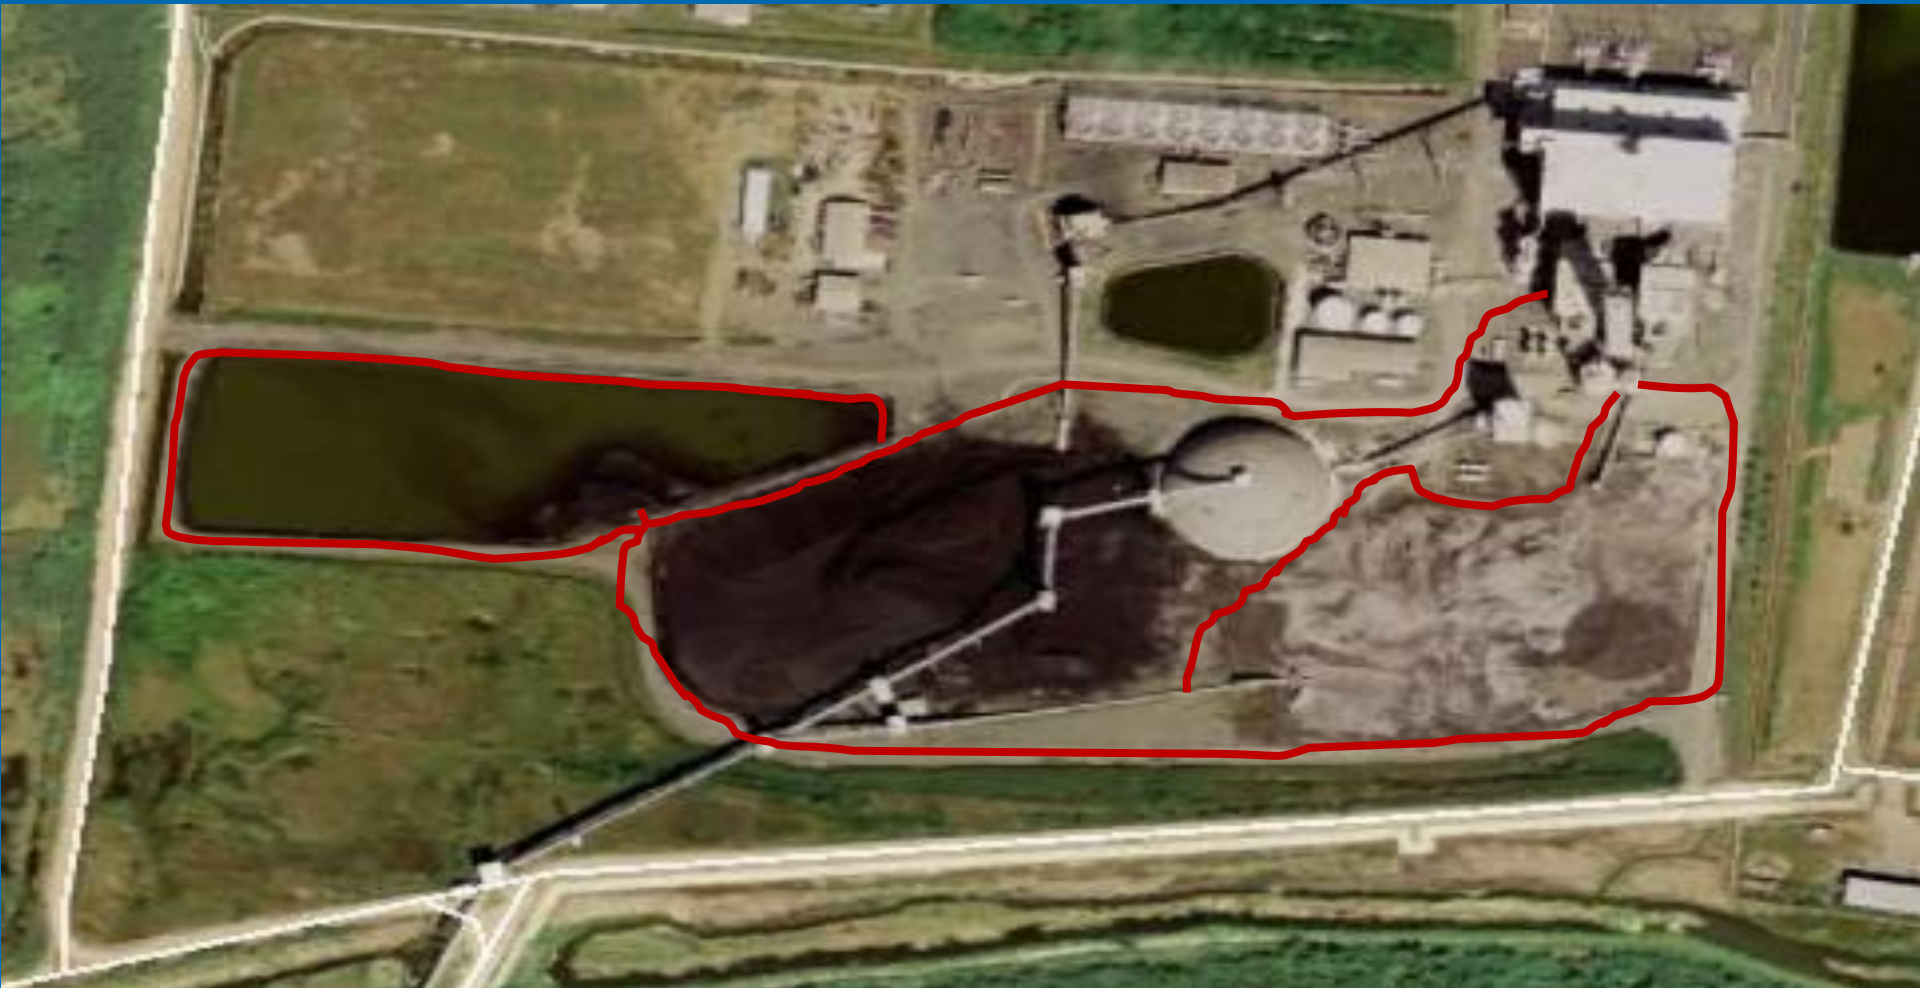
- Run-off (stormwater and process wastewater) from production and material storage areas is collected and conveyed into Coal Pile Runoff Pond through swales and channels. No discharge from this Pond into wetlands. All wastewater is re-used for water production and dust control.

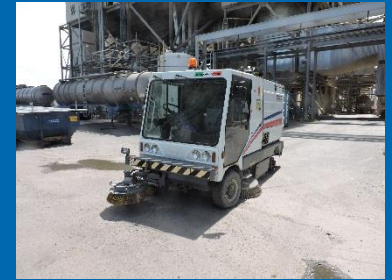
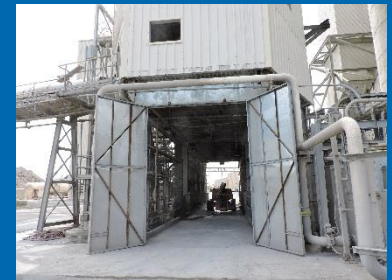
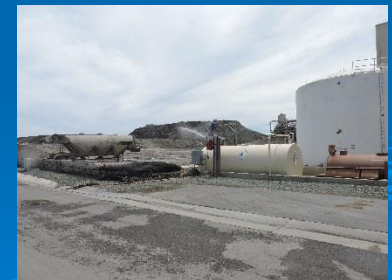
➤ Aggremax Pile

- 180,000 removed
- Were able to excavate to 4 feet bgl
- Work had to stop
- Sprinkler system
- Truck-mounted Sweeper
- Truck-mounted water sprinklers & cannon
- Speed limit
- Wheel washing station
